# Manhole Inspection Summary

Manhole # S57A\_\_012MH

Insp Date: **6/25/08 10:19 AM**

**Location** Address: **201 n haven st**

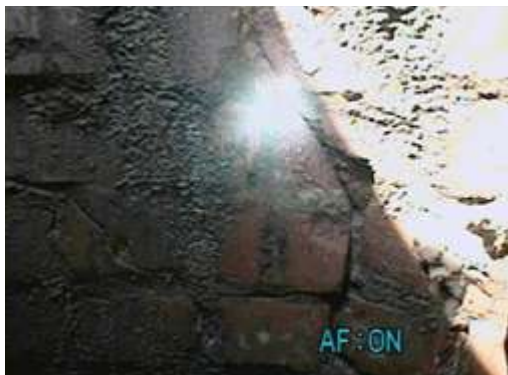
Defect 4

Condition: ☐ Sound ☒ **Cracked** ☐ Root Intrusion ☒ **Loose Brick** ☐ Deteriorated

corbel

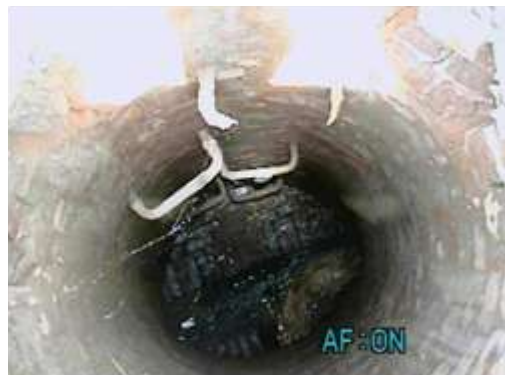
Defect 3

Count: **6** Missing: **1** ☒ **Corroded**

steps and surcharge evidence

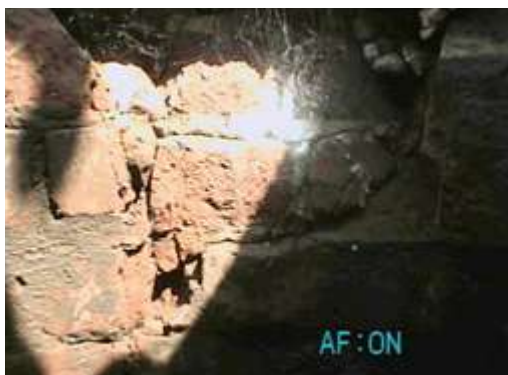
Defect 2

Condition: ☐ Sound ☒ **Cracked** ☐ Root Intrusion ☒ **Loose Brick** ☐ Deteriorated

frame adj

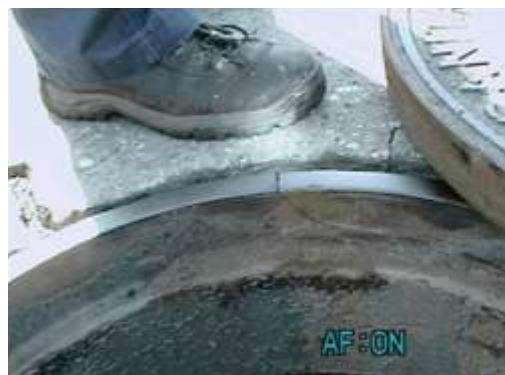
Defect 1

crack in the frame
